2023 FACILITY CONDITION SURVEY

Green River College

SURVEY CONDUCTED BY:
Steve Lewandowski
State Board for Community
and Technical Colleges

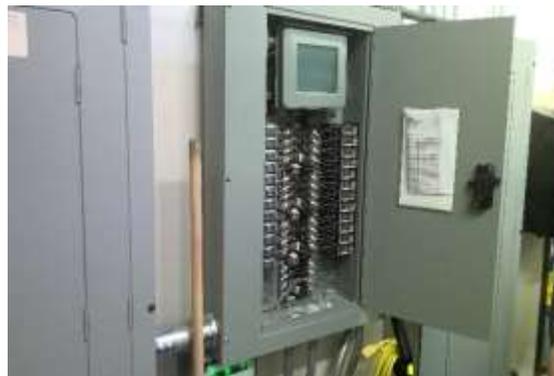
Estimated remaining life (years) : 5
Estimated average life expectancy (years) : 20
Scoring priority category 1 : High Repair/Repl. Cost (score = 12)
Category 1 percentage : 50 %
Scoring priority category 2 : System Use (score = 15)
Category 2 percentage : 50 %
Project construction estimate (MACC): \$225,000
Total project estimate (including soft costs): \$319,000
Additional points based on building condition: 0
Deficiency score : $2.5 \times ((12 \times 50\%) + (15 \times 50\%)) + 0 = 33.8$

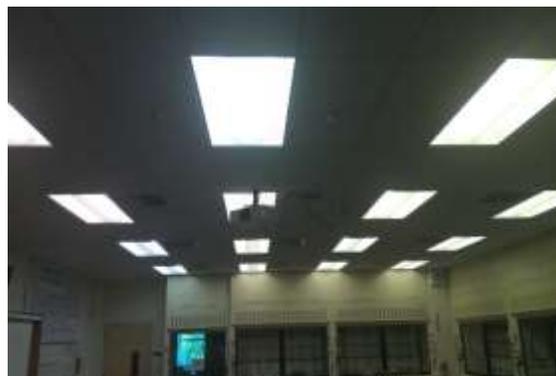
Deficiency F02

The Lutron zoned controllers have become less reliable. The main control server can no longer connect to the zoned controls. Parts are no longer available to repair the controllers. The controllers should be replaced.

Scoring priority category 1 : System Use (scoring weight=15)
Category 1 percentage : 60 %
Scoring priority category 2 : High Repair/Repl. Cost (scoring weight=12)
Category 2 percentage : 40 %
Project construction estimate (MACC): \$90,000
Total project estimate (including soft costs): \$127,000
Additional points based on building condition: 0
Deficiency score : $4 \times ((15 \times 60\%) + (12 \times 40\%)) + 0 = 55.2$

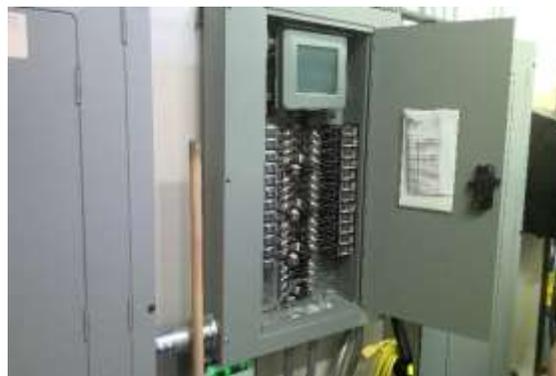
Deficiency F03

The Hubble lighting controls have become less reliable. The college believes that the vendor no longer supports the system. A memo is required to confirm that the system is no longer supported. If the controls are no longer supported, they should be replaced.

Estimated remaining life (years) : 5
Estimated average life expectancy (years) : 15
Scoring priority category 1 : High Repair/Repl. Cost (scoring weight=12)
Category 1 percentage : 50 %
Scoring priority category 2 : System Use (scoring weight=15)
Category 2 percentage : 50 %
Project construction estimate (MACC): \$90,000
Total project estimate (including soft costs): \$127,000
Additional points based on building condition: 0
Deficiency score : Needs study

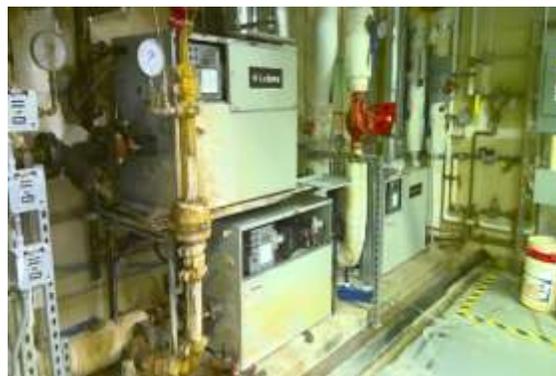
Deficiency F04

The three boilers are staged based on demand. Two of the boilers are beyond their useful life. One boiler is in better condition due to limited use and still functions as designed. The major components of the two heavily used boilers have been replaced. The boilers in the worst condition should be replaced.

Recommended funding schedule : Immediate (scoring weight=4)
Estimated remaining life (years) : 7
Estimated average life expectancy (years) : 20
Scoring priority category 1 : System Use (scoring weight=15)
Category 1 percentage : 60 %
Scoring priority category 2 : High Repair/Repl. Cost (scoring weight=12)
Category 2 percentage : 40 %
Project construction estimate (MACC): \$160,000
Total project estimate (including soft costs): \$226,000
Additional points based on building condition: 1
Deficiency score : $4 \times ((15 \times 60\%) + (12 \times 40\%)) + 1 = 56.2$

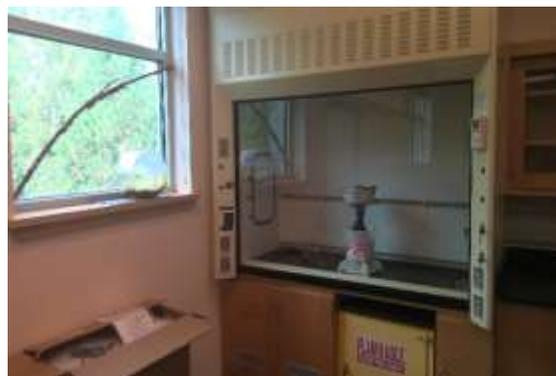
Deficiency F05

Several fume hoods have sashes that no longer regulate air flow properly. Some of the hoods have safety alarms that no longer function. Other hoods have various components that no longer function. The failed hoods should be repaired to regain full function.

Estimated average life expectancy (years) : 25
Scoring priority category 1 : High Repair/Repl. Cost (scoring weight=12)
Category 1 percentage : 70 %
Scoring priority category 2 : Health/Safety (scoring weight=25)
Category 2 percentage : 30 %
Project construction estimate (MACC): \$220,000
Total project estimate (including soft costs): \$312,000
Additional points based on building condition: 0
Deficiency score : $4 \times ((12 \times 70\%) + (25 \times 30\%)) + 0 = 63.6$

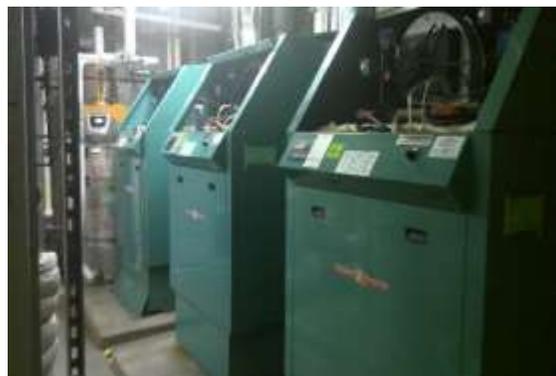
Deficiency F06

The three boiler controls have become unreliable. Since the building has only a single classroom with instructional use, the majority of the building must be maintained through the operating budget to support athletic programs. One of the boiler controls should be replaced.

Estimated remaining life (years) : 3
Estimated average life expectancy (years) : 20
Scoring priority category 1 : High Repair/Repl. Cost (scoring weight=12)
Category 1 percentage : 60 %
Scoring priority category 2 : System Use (scoring weight=15)
Category 2 percentage : 40 %
Project construction estimate (MACC): \$20,000
Total project estimate (including soft costs): \$28,000
Additional points based on building condition: 1
Deficiency score : $4 \times ((12 \times 60\%) + (15 \times 40\%)) + 1 = 53.8$

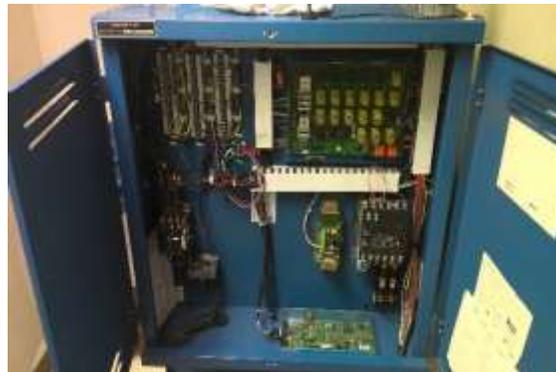
Deficiency F07

The Dover controls are no longer supported and cannot be easily repaired. The controls should be replaced to ensure that the elevator maintains full function and reliability.

Scoring priority category 1 : System Use (scoring weight=15)
Category 1 percentage : 50 %
Scoring priority category 2 : Facility Use/ Civil Rights Violation (scoring weight=20)
Category 2 percentage : 50 %
Project construction estimate (MACC): \$120,000
Total project estimate (including soft costs): \$170,000
Additional points based on building condition: 1
Deficiency score : $4 \times ((15 \times 50\%) + (20 \times 50\%)) + 1 = 71$

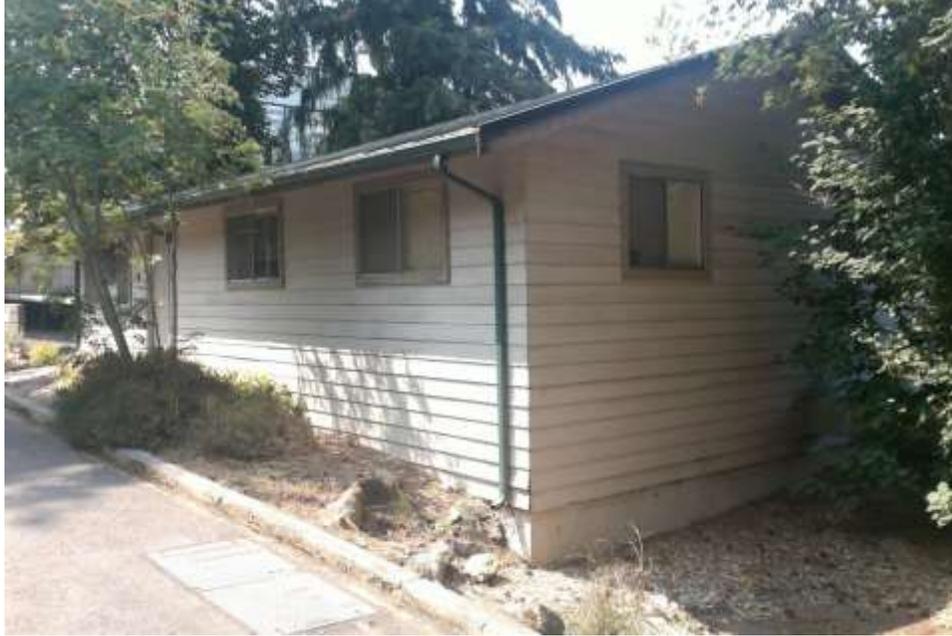
Human Resources (100-10) STATE UFI: A08781 Main Campus (100A)
 AREA: 1,118 SF BUILT: 1969 REMODELED: No PREDOMINANT USE: Classroom
 CONSTRUCTION TYPE: No data CRV/SF: \$356 REPLACEMENT VALUE: \$398,008

Primary Systems	
COMPONENT: Structure	RATING: 3 x WEIGHT: 8.8 = SCORE: 26.3
Some cracking evident but does not likely affect structural integrity; Visible defects apparent but are non-structural	
COMMENTS: No data	
COMPONENT: Exterior Closure	RATING: 3 x WEIGHT: 8.8 = SCORE: 26.3
Sound and weatherproof but with some physical deterioration evident	
COMMENTS: No data	
COMPONENT: Roofing	RATING: 3 x WEIGHT: 11 = SCORE: 32.9
Some deterioration is evident in membrane and flashings; maintenance or minor repair is needed	
COMMENTS: No data

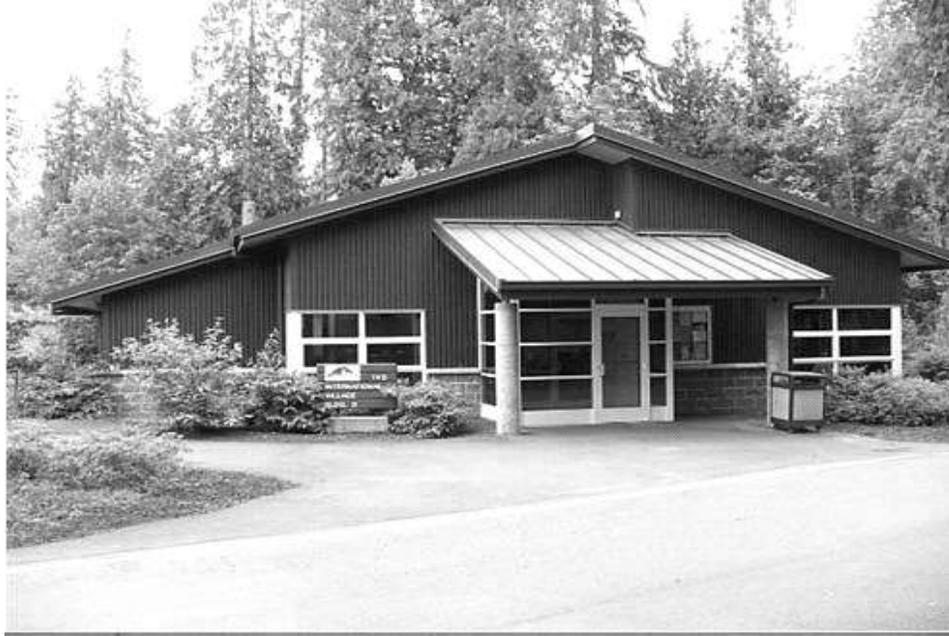
Intrntl Village Bldg "D" (100-44) STATE UFI: A03461 Main Campus (100A)
 AREA: 10,956 SF BUILT: 2002 REMODELED: No PREDOMINANT USE: Faculty Office
 CONSTRUCTION TYPE: Medium CRV/SF: \$376 REPLACEMENT VALUE: \$4,119,456

Primary Systems	
COMPONENT: Structure	RATING: 3 x WEIGHT: 8.8 = SCORE: 26.3
Some cracking evident but does not likely affect structural integrity; Visible defects apparent but are non-structural	
COMMENTS:	Wood frame and glu lams; concrete; steel; CMU base
COMPONENT: Exterior Closure	RATING: 1 x WEIGHT: 8.8 = SCORE: 8.8
Weatherproof, tight, well-maintained exterior walls, doors, windows/finishes	
COMMENTS:	Box rib metal siding; split face CMU; precast concrete wainscoting cap
COMPONENT: Roofing	RATING: 1 x WEIGHT: 11 = SCORE: 11
Flashing and penetrations appear sound and membrane appears water- tight; drainage is positive and there are overflow scuppers	
COMMENTS:	Standing seam metal

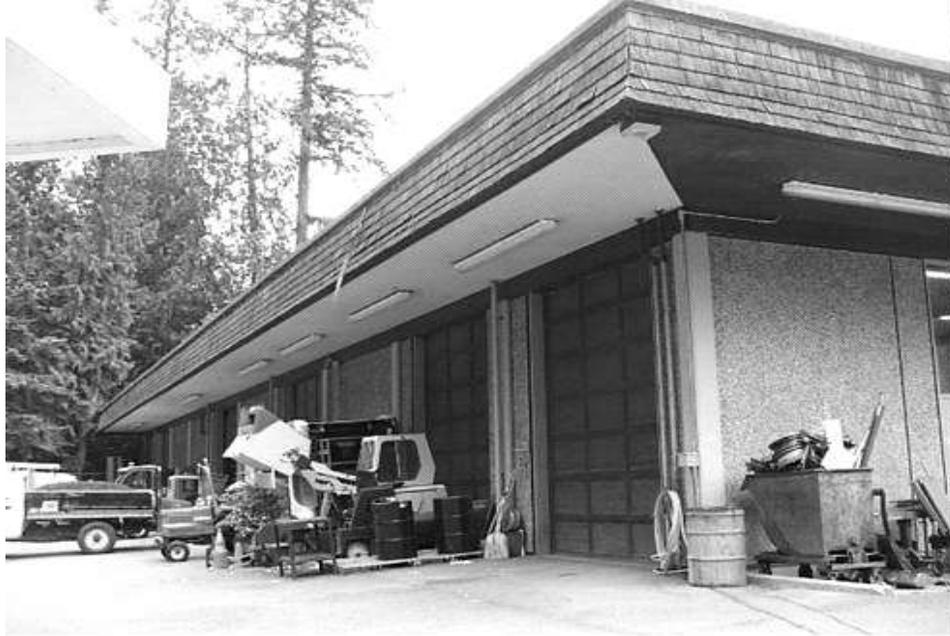
Maintenance Center (100-21) STATE UFI: A06022 Main Campus (100A)
 AREA: 6,000 SF BUILT: 1977 REMODELED: No PREDOMINANT USE: Maintenance
 CONSTRUCTION TYPE: Medium CRV/SF: \$349 REPLACEMENT VALUE: \$2,094,000

Primary Systems	
COMPONENT: Structure	RATING: 3 x WEIGHT: 8.3 = SCORE: 25
Some cracking evident but does not likely affect structural integrity; Visible defects apparent but are non-structural	
COMMENTS: Concrete frame; CMU; roof trusses	
COMPONENT: Exterior Closure	RATING: 2 x WEIGHT: 8.3 = SCORE: 16.7
Weatherproof exterior, but finish appears poorly maintained	
COMMENTS: Exposed marble aggregate panels; wood soffits	
COMPONENT: Roofing	RATING: 2 x WEIGHT: 10.4 = SCORE: 20.9
Majority of roofing and flashing appear sound, but a small portion of roofing shows deterioration where maintenance or minor repair needed	
COMMENTS: Fully adhered EPDM-2007; wood mansards. Repairs funded 21-23

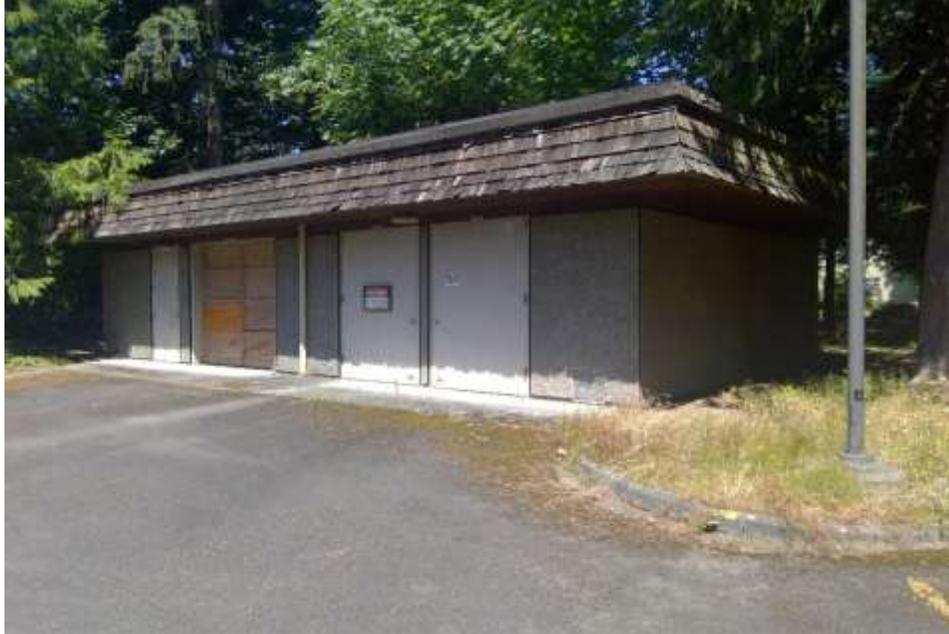
Trades & Industry "E" (100-22) STATE UFI: A03713 Main Campus (100A)
 AREA: 840 SF BUILT: 1976 REMODELED: No PREDOMINANT USE: Storage
 CONSTRUCTION TYPE: Medium CRV/SF: \$231 REPLACEMENT VALUE: \$194,040

Primary Systems	
COMPONENT: Structure	RATING: 3 x WEIGHT: 9.2 = SCORE: 27.6
Some cracking evident but does not likely affect structural integrity; Visible defects apparent but are non-structural	
COMMENTS: CMU; concrete columns	
COMPONENT: Exterior Closure	RATING: 4 x WEIGHT: 9.2 = SCORE: 36.8
General deterioration detected, one or more minor leaks apparent	
COMMENTS: Concrete panels; wood soffits	
COMPONENT: Roofing	RATING: 4 x WEIGHT: 11.5 = SCORE: 46
General deterioration and some leaks are evident; reconditioning or partial repair is needed	
COMMENTS: Built-up roof; mansard cedar shingles
