2023 FACILITY CONDITION SURVEY

Green River College

SURVEY CONDUCTED BY:
Steve Lewandowski
State Board for Community
and Technical Colleges

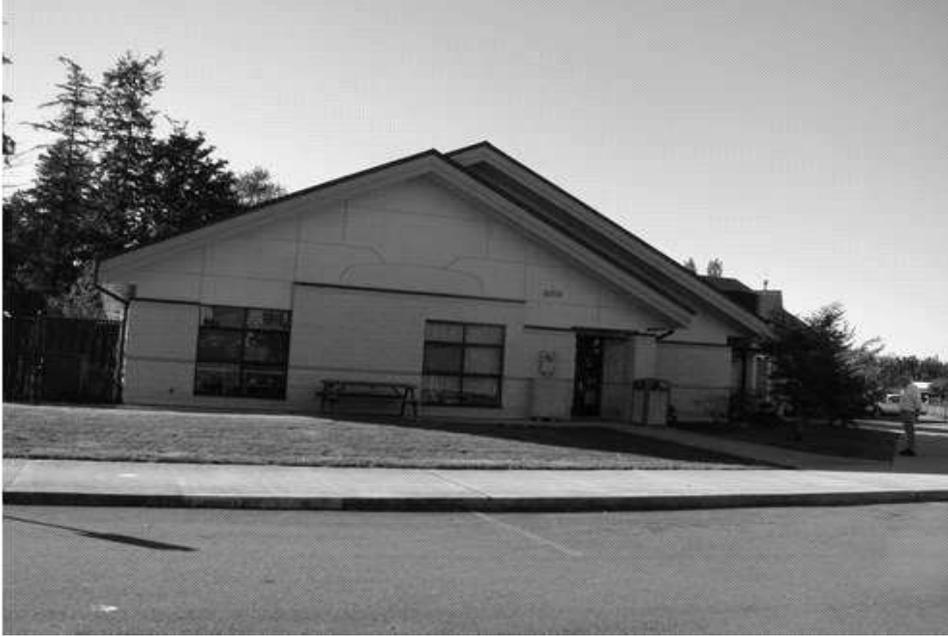
Child Care Center (100-32) STATE UFI: A09404 Child Care Site (100F)
 AREA: 5,940 SF BUILT: 1996 REMODELED: No PREDOMINANT USE: Child Care
 CONSTRUCTION TYPE: Light CRV/SF: \$264 REPLACEMENT VALUE: \$1,568,160

Primary Systems	
COMPONENT: Structure	RATING: 1 x WEIGHT: 8.8 = SCORE: 8.8
No signs of settlement or cracking, no abrupt vertical changes Columns, bearing walls and roof structure appears sound/free of defects	
COMMENTS: Split-face CMU; wood frame	
COMPONENT: Exterior Closure	RATING: 1 x WEIGHT: 8.8 = SCORE: 8.8
Weatherproof, tight, well-maintained exterior walls, doors, windows/finishes	
COMMENTS: CMU; wood fascia; stucco; wood soffits	
COMPONENT: Roofing	RATING: 3 x WEIGHT: 11 = SCORE: 32.9
Some deterioration is evident in membrane and flashings; maintenance or minor repair is needed	
COMMENTS: Composition shingle. Repairs funded in 21-23

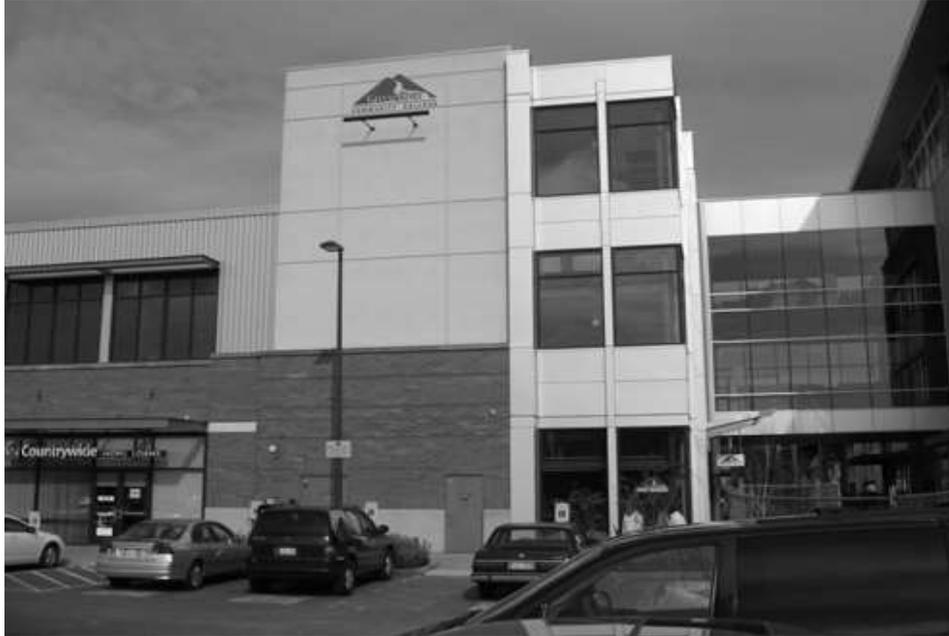
Kent Campus (100-48) STATE UFI: A05349 Kent Campus (100D)
 AREA: 22,192 SF BUILT: 2005 REMODELED: No PREDOMINANT USE: General Classroom
 CONSTRUCTION TYPE: Medium CRV/SF: \$296 REPLACEMENT VALUE: \$6,568,832

Primary Systems	
COMPONENT: Structure	RATING: 1 x WEIGHT: 8.4 = SCORE: 8.4
No signs of settlement or cracking, no abrupt vertical changes Columns, bearing walls and roof structure appears sound/free of defects	
COMMENTS: Metal frame; brick; concrete	
COMPONENT: Exterior Closure	RATING: 1 x WEIGHT: 8.4 = SCORE: 8.4
Weatherproof, tight, well-maintained exterior walls, doors, windows/finishes	
COMMENTS: Metal panels; concrete; brick; stucco panels; aluminum window walls	
COMPONENT: Roofing	RATING: 2 x WEIGHT: 10.5 = SCORE: 21
Majority of roofing and flashing appear sound, but a small portion of roofing shows deterioration where maintenance or minor repair needed	
COMMENTS: Single-ply TPO membrane

Secondary Systems			
COMPONENT:	Floor Finishes	RATING: 1 x	WEIGHT: 6.3 = SCORE: 6.3
Nice appearance, smooth transitions, level subfloors, no cracks/separating			
COMMENTS:	Carpet; sheet flooring; ceramic tile		
COMPONENT:	Wall Finishes	RATING: 1 x	WEIGHT: 6.3 = SCORE: 6.3
Maintainable surfaces in good condition			
COMMENTS:	Ceramic tile; vinyl wall covering; gypsum board; slate		
COMPONENT:	Ceiling Finishes	RATING: 1 x	WEIGHT: 6.3 = SCORE: 6.3
Maintainable surfaces in good condition; good alignment and appearance			
COMMENTS:	Gypsum board and lay-in tile		
COMPONENT:	Doors & Hardware	RATING: 1 x	WEIGHT: 6.3 = SCORE: 6.3
Appropriate hardware, closers, panic devices; in good working order			
COMMENTS:	Interior wood doors/aluminum frames; exterior aluminum doors/frames

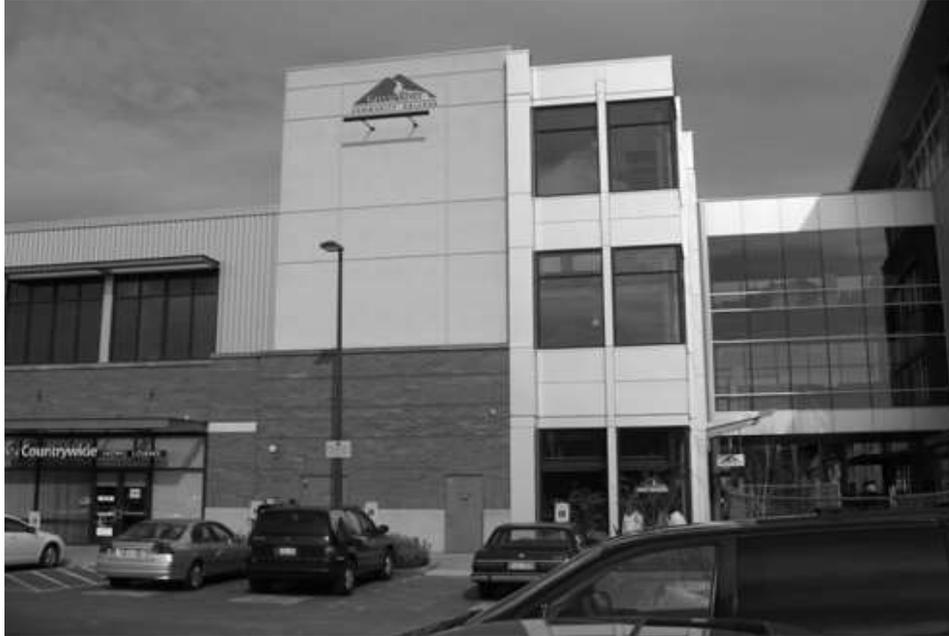
Kent Campus, Phase 2 (100-48) STATE UFI: A10362 Kent Campus (100D)
 AREA: 43,526 SF BUILT: 2009 REMODELED: No PREDOMINANT USE: Classroom
 CONSTRUCTION TYPE: Medium CRV/SF: \$356 REPLACEMENT VALUE: \$15,495,256

Primary Systems	
COMPONENT: Structure	RATING: 1 x WEIGHT: 8.4 = SCORE: 8.4
No signs of settlement or cracking, no abrupt vertical changes Columns, bearing walls and roof structure appears sound/free of defects	
COMMENTS: Metal frame; brick; concrete	
COMPONENT: Exterior Closure	RATING: 1 x WEIGHT: 8.4 = SCORE: 8.4
Weatherproof, tight, well-maintained exterior walls, doors, windows/finishes	
COMMENTS: Metal panels; concrete; brick; stucco panels; aluminum window walls	
COMPONENT: Roofing	RATING: 1 x WEIGHT: 10.5 = SCORE: 10.5
Flashing and penetrations appear sound and membrane appears water- tight; drainage is positive and there are overflow scuppers	
COMMENTS: Single-ply TPO membrane

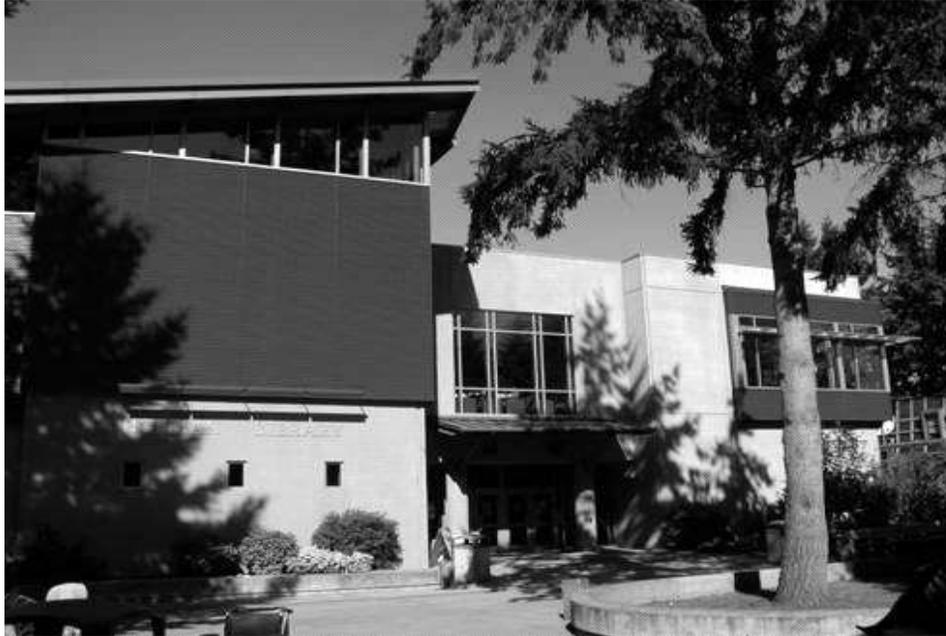
(New) Holman Library (100-33) STATE UFI: A07353 Main Campus (100A)
 AREA: 57,333 SF BUILT: 1996 REMODELED: No PREDOMINANT USE: Library
 CONSTRUCTION TYPE: Heavy CRV/SF: \$376 REPLACEMENT VALUE: \$21,557,208

Primary Systems	
COMPONENT: Structure	RATING: 1 x WEIGHT: 8 = SCORE: 8
No signs of settlement or cracking, no abrupt vertical changes Columns, bearing walls and roof structure appears sound/free of defects	
COMMENTS: Structural steel; concrete columns	
COMPONENT: Exterior Closure	RATING: 1 x WEIGHT: 8 = SCORE: 8
Weatherproof, tight, well-maintained exterior walls, doors, windows/finishes	
COMMENTS: Tilt-up concrete panels; corrugated metal panels; concrete panels	
COMPONENT: Roofing	RATING: 1 x WEIGHT: 10 = SCORE: 10
Flashing and penetrations appear sound and membrane appears water- tight; drainage is positive and there are overflow scuppers	
COMMENTS: Standing seam metal; Hypalon single ply 2020

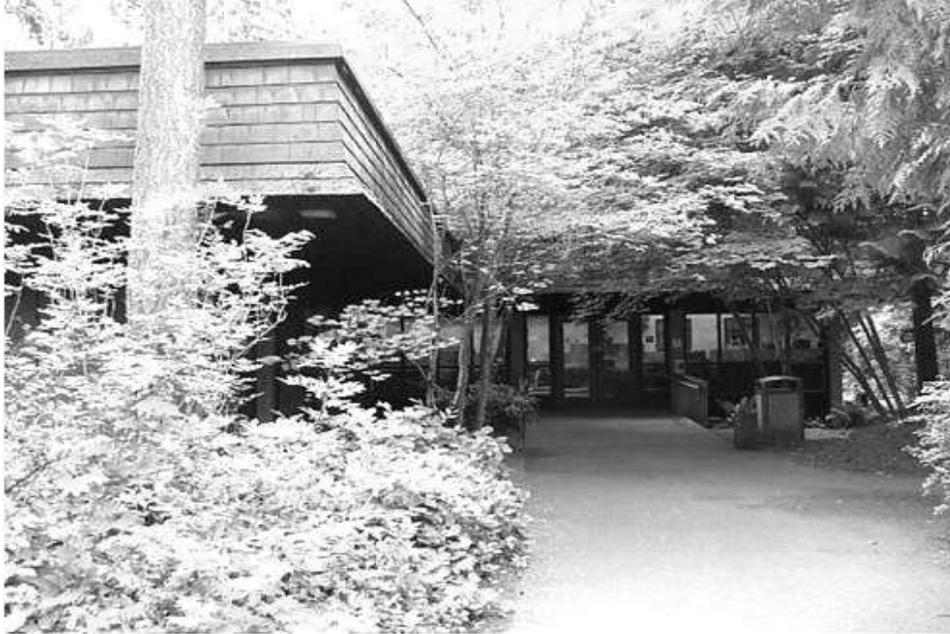
Administration (100-20) STATE UFI: A07509 Main Campus (100A)
 AREA: 9,765 SF BUILT: 1976 REMODELED: No PREDOMINANT USE: Administration
 CONSTRUCTION TYPE: Medium CRV/SF: \$336 REPLACEMENT VALUE: \$3,281,040

Primary Systems	
COMPONENT: Structure	RATING: 1 x WEIGHT: 8.3 = SCORE: 8.3
No signs of settlement or cracking, no abrupt vertical changes Columns, bearing walls and roof structure appears sound/free of defects	
COMMENTS: Concrete frame, glu-lam beams, wood roof trusses	
COMPONENT: Exterior Closure	RATING: 1 x WEIGHT: 8.3 = SCORE: 8.3
Weatherproof, tight, well-maintained exterior walls, doors, windows/finishes	
COMMENTS: Exposed aggregate cement panels; concrete base; wood soffits; ss metal mansards	
COMPONENT: Roofing	RATING: 1 x WEIGHT: 10.4 = SCORE: 10.4
Flashing and penetrations appear sound and membrane appears water- tight; drainage is positive and there are overflow scuppers	
COMMENTS: TPO 2022

Secondary Systems			
COMPONENT:	Floor Finishes	RATING: 1 x WEIGHT: 6.3 =	SCORE: 6.3
Nice appearance, smooth transitions, level subfloors, no cracks/separating			
COMMENTS:	Carpet-surface wear; ceramic tile		
COMPONENT:	Wall Finishes	RATING: 1 x WEIGHT: 6.3 =	SCORE: 6.3
Maintainable surfaces in good condition			
COMMENTS:	Gypsum board; wood strip paneling; moveable walls; plastic panels		
COMPONENT:	Ceiling Finishes	RATING: 1 x WEIGHT: 6.3 =	SCORE: 6.3
Maintainable surfaces in good condition; good alignment and appearance			
COMMENTS:	Lay-in tile; non-standard sizes and suspension		
COMPONENT:	Doors & Hardware	RATING: 1 x WEIGHT: 6.3 =	SCORE: 6.3
Appropriate hardware, closers, panic devices; in good working order			
COMMENTS:	Interior wood doors/KD frames; exterior HM doors/frames

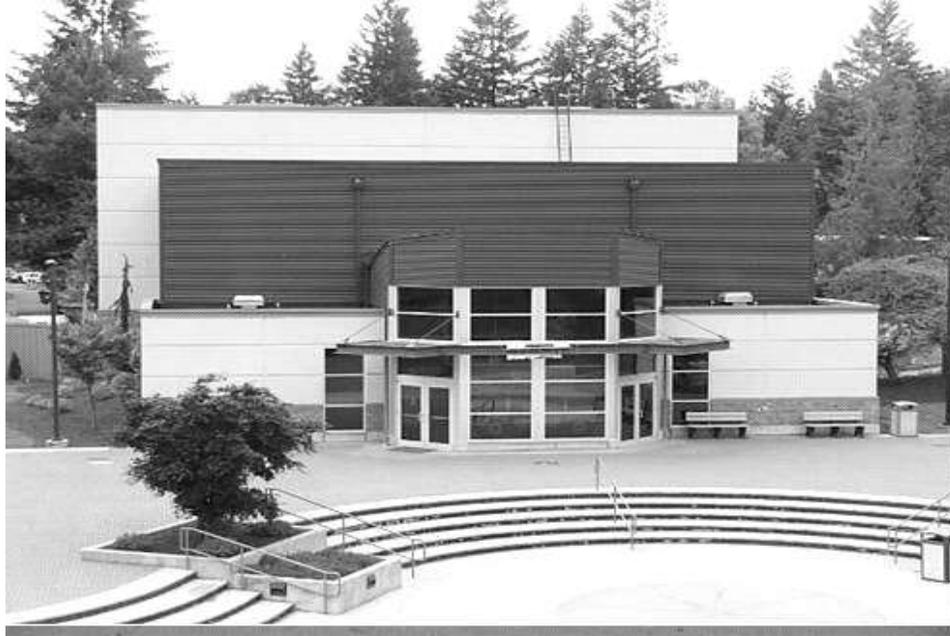
Bleha Prfrming Arts Cntr (100-43) STATE UFI: A05427 Main Campus (100A)
 AREA: 20,178 SF BUILT: 2000 REMODELED: No PREDOMINANT USE: Performing Arts
 CONSTRUCTION TYPE: Heavy CRV/SF: \$421 REPLACEMENT VALUE: \$8,494,938

Primary Systems	
COMPONENT: Structure	RATING: 1 x WEIGHT: 8.8 = SCORE: 8.8
No signs of settlement or cracking, no abrupt vertical changes Columns, bearing walls and roof structure appears sound/free of defects	
COMMENTS: Structural steel	
COMPONENT: Exterior Closure	RATING: 1 x WEIGHT: 8.8 = SCORE: 8.8
Weatherproof, tight, well-maintained exterior walls, doors, windows/finishes	
COMMENTS: CMU; corrugated metal panels; EIFS; structural polycarbonate canopy panels	
COMPONENT: Roofing	RATING: 1 x WEIGHT: 11 = SCORE: 11
Flashing and penetrations appear sound and membrane appears water- tight; drainage is positive and there are overflow scuppers	
COMMENTS: Single ply EPDM

Secondary Systems			
COMPONENT:	Floor Finishes	RATING: 2 x	WEIGHT: 6.6 = SCORE: 13.2
Some wear is evident on finish; maintenance needed			
COMMENTS:	Vinyl tile; carpet-surface wear & failing seams; ceramic tile; concrete; hardboard stage flooring-surface wear		
COMPONENT:	Wall Finishes	RATING: 2 x	WEIGHT: 6.6 = SCORE: 13.2
Maintainable surfaces, minor maintenance is required in some areas			
COMMENTS:	Gypsum board; wood panels; fabric panels; wood base; ceramic tile		
COMPONENT:	Ceiling Finishes	RATING: 1 x	WEIGHT: 6.6 = SCORE: 6.6
Maintainable surfaces in good condition; good alignment and appearance			
COMMENTS:	Gypsum board; lay-in tile; metal deck pan		
COMPONENT:	Doors & Hardware	RATING: 2 x	WEIGHT: 6.6 = SCORE: 13.2
Fairly modern door surfaces and hardware with minor deterioration; good working order			
COMMENTS:	Interior/exterior HM doors/frames-surface wear; exterior aluminum doors/frames

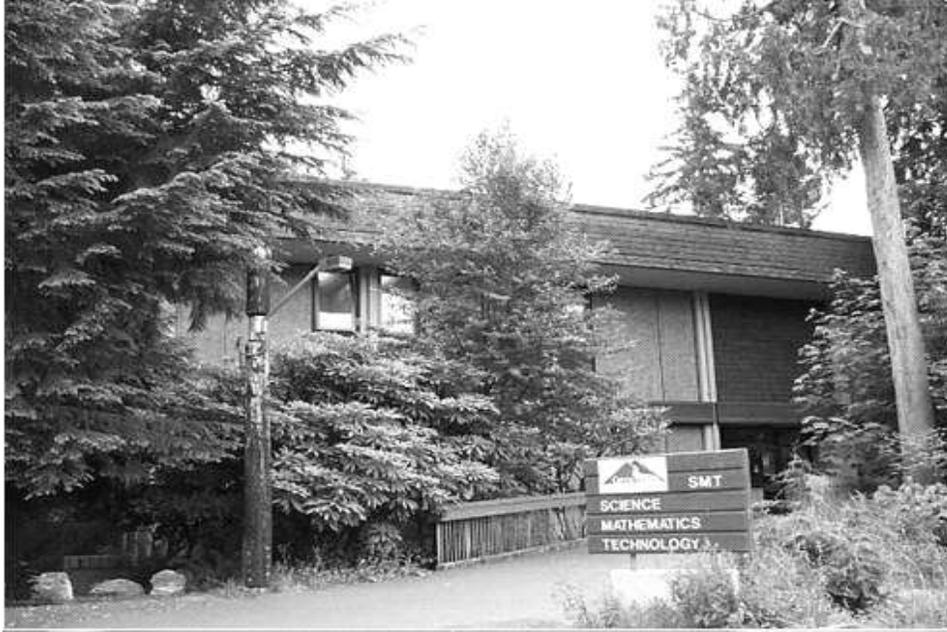
Cedar Hall (100-18) STATE UFI: A08273 Main Campus (100A)
 AREA: 54,000 SF BUILT: 1974 REMODELED: 2013 PREDOMINANT USE: Classroom/Office
 CONSTRUCTION TYPE: Heavy CRV/SF: \$376 REPLACEMENT VALUE: \$20,304,000

Primary Systems	
COMPONENT: Structure	RATING: 1 x WEIGHT: 8 = SCORE: 8
No signs of settlement or cracking, no abrupt vertical changes Columns, bearing walls and roof structure appears sound/free of defects	
COMMENTS:	
COMPONENT: Exterior Closure	RATING: 1 x WEIGHT: 8 = SCORE: 8
Weatherproof, tight, well-maintained exterior walls, doors, windows/finishes	
COMMENTS:	
COMPONENT: Roofing	RATING: 1 x WEIGHT: 10 = SCORE: 10
Flashing and penetrations appear sound and membrane appears water-tight; drainage is positive and there are overflow scuppers	
COMMENTS:

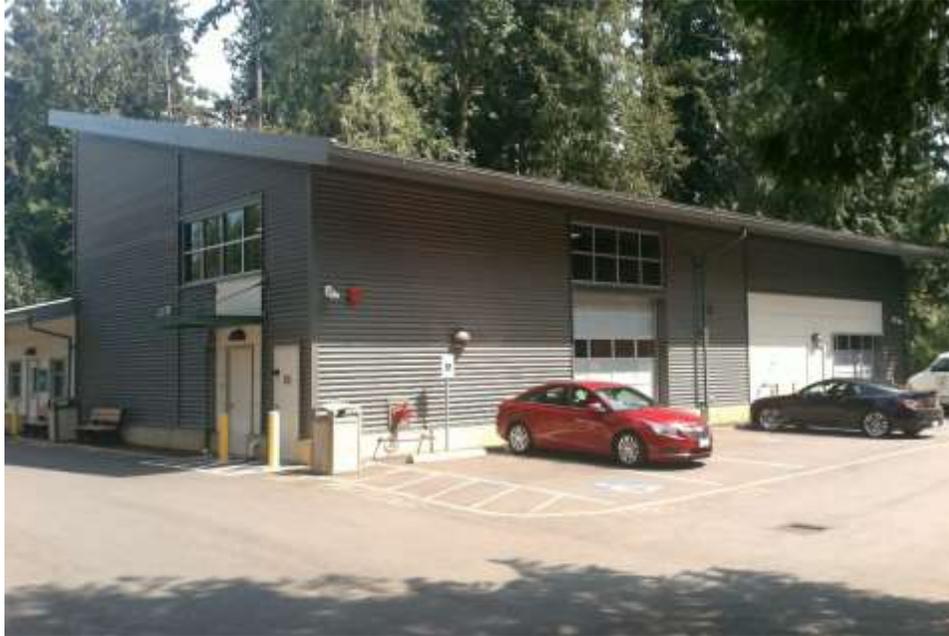
Facilities Operations (100-51) STATE UFI: A10150 Main Campus (100A)
 AREA: 8,693 SF BUILT: 2012 REMODELED: No PREDOMINANT USE: Classroom
 CONSTRUCTION TYPE: No data CRV/SF: \$356 REPLACEMENT VALUE: \$3,094,708

Primary Systems	
COMPONENT: Structure	RATING: 1 x WEIGHT: 8.8 = SCORE: 8.8
No signs of settlement or cracking, no abrupt vertical changes Columns, bearing walls and roof structure appears sound/free of defects	
COMMENTS: No data	
COMPONENT: Exterior Closure	RATING: 1 x WEIGHT: 8.8 = SCORE: 8.8
Weatherproof, tight, well-maintained exterior walls, doors, windows/finishes	
COMMENTS: No data	
COMPONENT: Roofing	RATING: 1 x WEIGHT: 11 = SCORE: 11
Flashing and penetrations appear sound and membrane appears water- tight; drainage is positive and there are overflow scuppers	
COMMENTS: metal

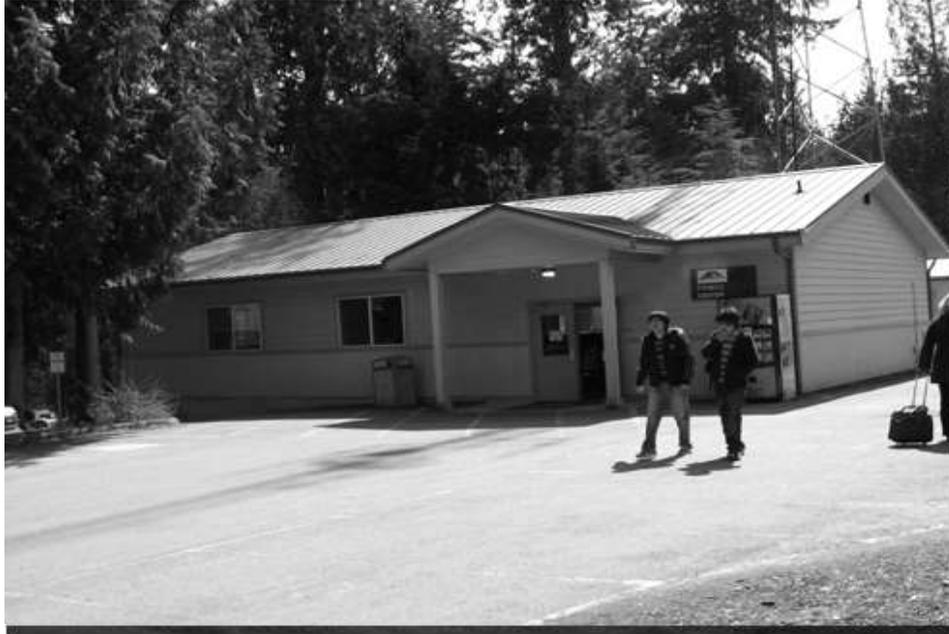
Fitness Center (100-39) STATE UFI: A03441 Main Campus (100A)
 AREA: 1,740 SF BUILT: 1995 REMODELED: No PREDOMINANT USE: Gymnasium
 CONSTRUCTION TYPE: Light CRV/SF: \$231 REPLACEMENT VALUE: \$401,940

Primary Systems	
COMPONENT: Structure	RATING: 1 x WEIGHT: 9.2 = SCORE: 9.2
No signs of settlement or cracking, no abrupt vertical changes Columns, bearing walls and roof structure appears sound/free of defects	
COMMENTS: Wood frame; concrete foundation	
COMPONENT: Exterior Closure	RATING: 1 x WEIGHT: 9.2 = SCORE: 9.2
Weatherproof, tight, well-maintained exterior walls, doors, windows/finishes	
COMMENTS: Horizontal beveled fiberboard; T1-11 plywood; plywood soffits	
COMPONENT: Roofing	RATING: 1 x WEIGHT: 11.5 = SCORE: 11.5
Flashing and penetrations appear sound and membrane appears water- tight; drainage is positive and there are overflow scuppers	
COMMENTS: Standing seam metal

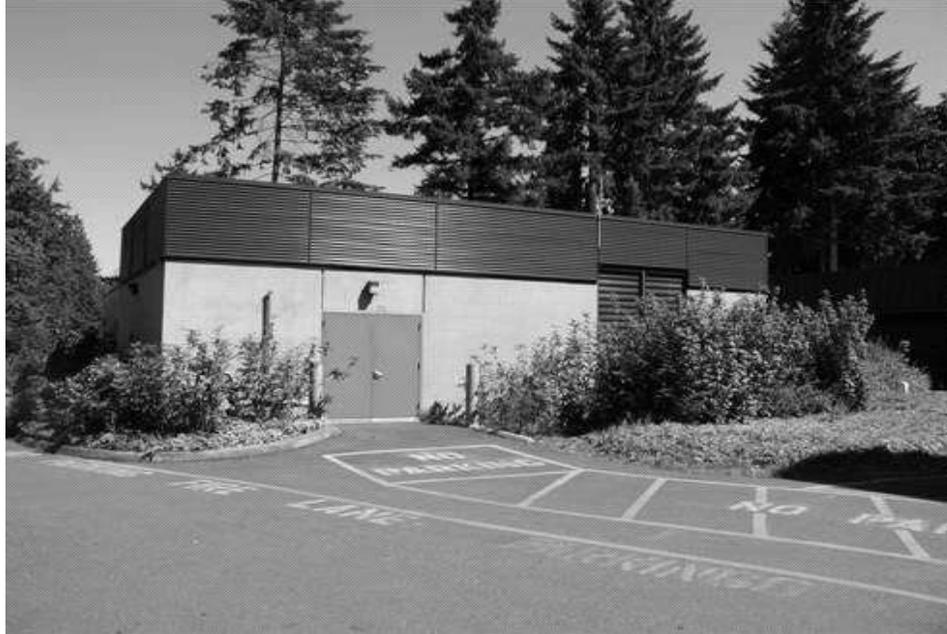
Hlb/Rlc Plant Bldg (100-41) STATE UFI: A07419 Main Campus (100A)
 AREA: 1,034 SF BUILT: 1996 REMODELED: No PREDOMINANT USE: Central Plant
 CONSTRUCTION TYPE: Medium CRV/SF: \$231 REPLACEMENT VALUE: \$238,854

Primary Systems	
COMPONENT: Structure	RATING: 1 x WEIGHT: 9.7 = SCORE: 9.7
No signs of settlement or cracking, no abrupt vertical changes Columns, bearing walls and roof structure appears sound/free of defects	
COMMENTS: Concrete; metal roof framing	
COMPONENT: Exterior Closure	RATING: 2 x WEIGHT: 9.7 = SCORE: 19.3
Weatherproof exterior, but finish appears poorly maintained	
COMMENTS: Metal architectural panels; concrete	
COMPONENT: Roofing	RATING: 2 x WEIGHT: 12.1 = SCORE: 24.1
Majority of roofing and flashing appear sound, but a small portion of roofing shows deterioration where maintenance or minor repair needed	
COMMENTS: Standing seam metal

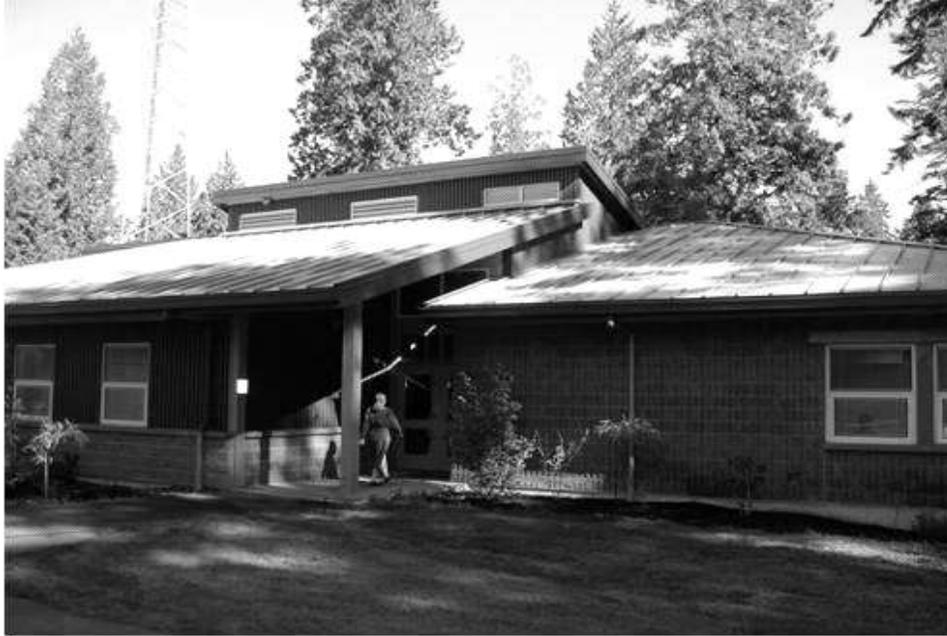
Intrntl Village Bldg "A" (100-37) STATE UFI: A05458 Main Campus (100A)
 AREA: 4,800 SF BUILT: 1996 REMODELED: No PREDOMINANT USE: General Classroom
 CONSTRUCTION TYPE: Medium CRV/SF: \$376 REPLACEMENT VALUE: \$1,804,800

Primary Systems	
COMPONENT: Structure	RATING: 2 x WEIGHT: 8.3 = SCORE: 16.7
Minor cracks evident in a small portion of the structure	
COMMENTS: CMU base; wood frame; glu-lam beams and rafters	
COMPONENT: Exterior Closure	RATING: 1 x WEIGHT: 8.3 = SCORE: 8.3
Weatherproof, tight, well-maintained exterior walls, doors, windows/finishes	
COMMENTS: Split face CMU; box rib metal siding; pre-cast concrete trim band; wood soffits	
COMPONENT: Roofing	RATING: 1 x WEIGHT: 10.4 = SCORE: 10.4
Flashing and penetrations appear sound and membrane appears water-tight; drainage is positive and there are overflow scuppers	
COMMENTS: Standing seam metal

Secondary Systems			
COMPONENT:	Floor Finishes	RATING: 2 x	WEIGHT: 6.3 = SCORE: 12.5
Some wear is evident on finish; maintenance needed			
COMMENTS:	Carpet-surface wear		
COMPONENT:	Wall Finishes	RATING: 1 x	WEIGHT: 6.3 = SCORE: 6.3
Maintainable surfaces in good condition			
COMMENTS:	CMU; metal panels; wood panels; gypsum board		
COMPONENT:	Ceiling Finishes	RATING: 1 x	WEIGHT: 6.3 = SCORE: 6.3
Maintainable surfaces in good condition; good alignment and appearance			
COMMENTS:	Gypsum board; suspended Act; wood strip		
COMPONENT:	Doors & Hardware	RATING: 2 x	WEIGHT: 6.3 = SCORE: 12.5
Fairly modern door surfaces and hardware with minor deterioration; good working order			
COMMENTS:	Interior wood doors/HM frames-surface wear; exterior HM doors/frames

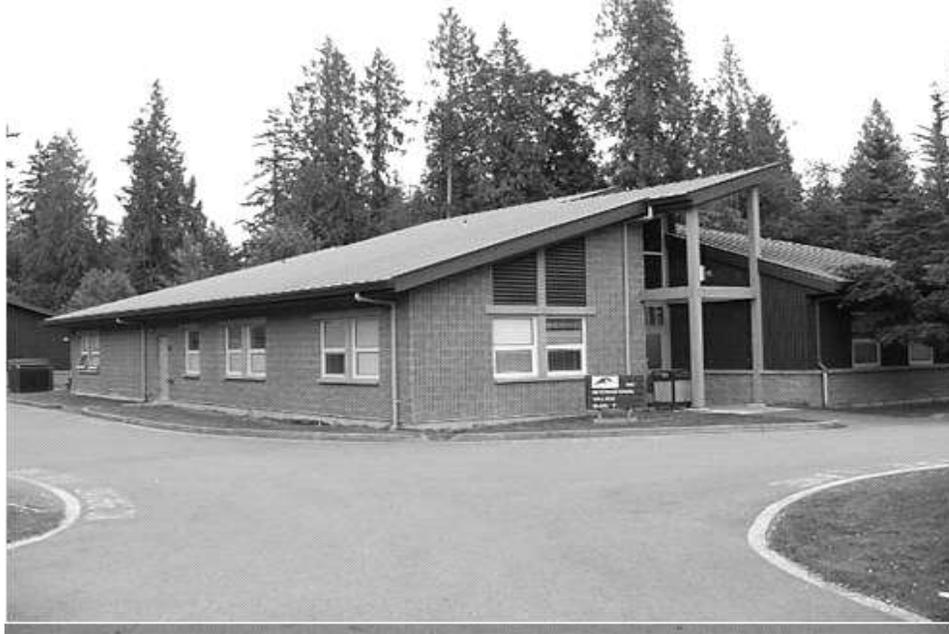
Intrntl Village Bldg "C" (100-42) STATE UFI: A06660 Main Campus (100A)
 AREA: 4,800 SF BUILT: 1999 REMODELED: No PREDOMINANT USE: General Classroom
 CONSTRUCTION TYPE: Medium CRV/SF: \$376 REPLACEMENT VALUE: \$1,804,800

Primary Systems	
COMPONENT: Structure	RATING: 2 x WEIGHT: 8.8 = SCORE: 17.6
Minor cracks evident in a small portion of the structure	
COMMENTS: Split-face CMU base; wood frame; glu-lam beams	
COMPONENT: Exterior Closure	RATING: 1 x WEIGHT: 8.8 = SCORE: 8.8
Weatherproof, tight, well-maintained exterior walls, doors, windows/finishes	
COMMENTS: Split face CMU; box rib metal siding; pre-cast concrete trim band; wood soffits	
COMPONENT: Roofing	RATING: 1 x WEIGHT: 11 = SCORE: 11
Flashing and penetrations appear sound and membrane appears water- tight; drainage is positive and there are overflow scuppers	
COMMENTS: Standing seam metal

Secondary Systems			
COMPONENT:	Floor Finishes	RATING: 2 x	WEIGHT: 6.6 = SCORE: 13.2
Some wear is evident on finish; maintenance needed			
COMMENTS:	Carpet-surface wear		
COMPONENT:	Wall Finishes	RATING: 2 x	WEIGHT: 6.6 = SCORE: 13.2
Maintainable surfaces, minor maintenance is required in some areas			
COMMENTS:	CMU; box rib metal panels; wood panels; gypsum board-dents/marred		
COMPONENT:	Ceiling Finishes	RATING: 1 x	WEIGHT: 6.6 = SCORE: 6.6
Maintainable surfaces in good condition; good alignment and appearance			
COMMENTS:	Gypsum board and suspended ceilings; wood strip		
COMPONENT:	Doors & Hardware	RATING: 2 x	WEIGHT: 6.6 = SCORE: 13.2
Fairly modern door surfaces and hardware with minor deterioration; good working order			
COMMENTS:	Interior wood doors-surface wear/HM frames; exterior HM doors/frames

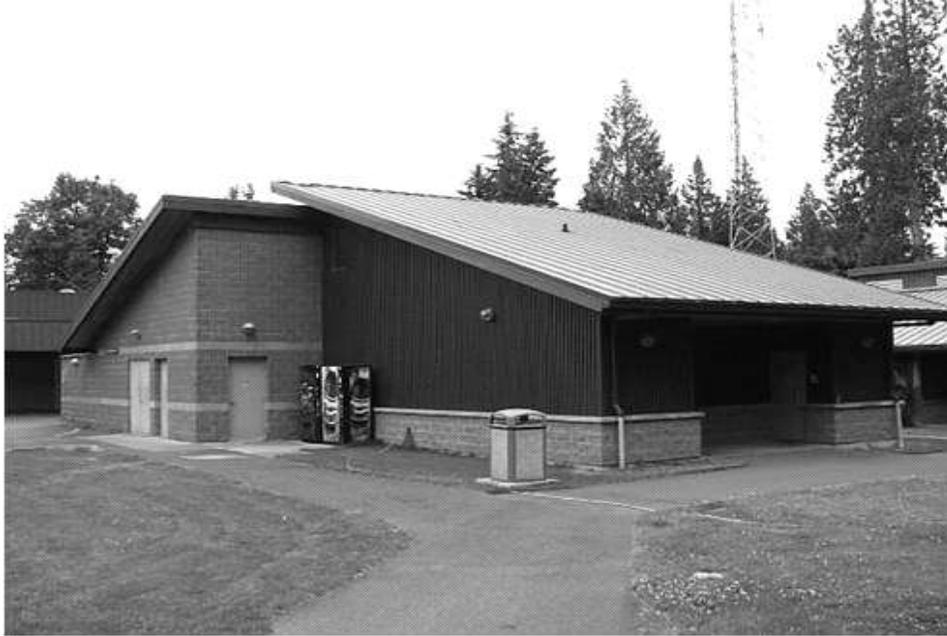
Intrntnl Village Bldg "B" (100-40) STATE UFI: A06226 Main Campus (100A)
 AREA: 2,344 SF BUILT: 1996 REMODELED: 1999 PREDOMINANT USE: Central Plant
 CONSTRUCTION TYPE: Medium CRV/SF: \$376 REPLACEMENT VALUE: \$881,344

Primary Systems	
COMPONENT: Structure	RATING: 2 x WEIGHT: 9.2 = SCORE: 18.4
Minor cracks evident in a small portion of the structure	
COMMENTS: CMU base; concrete; wood frame; wood/steel roof trusses	
COMPONENT: Exterior Closure	RATING: 1 x WEIGHT: 9.2 = SCORE: 9.2
Weatherproof, tight, well-maintained exterior walls, doors, windows/finishes	
COMMENTS: Split-face CMU; box rib metal siding; precast concrete trim band; wood soffits	
COMPONENT: Roofing	RATING: 1 x WEIGHT: 11.5 = SCORE: 11.5
Flashing and penetrations appear sound and membrane appears water-tight; drainage is positive and there are overflow scuppers	
COMMENTS: Standing seam metal

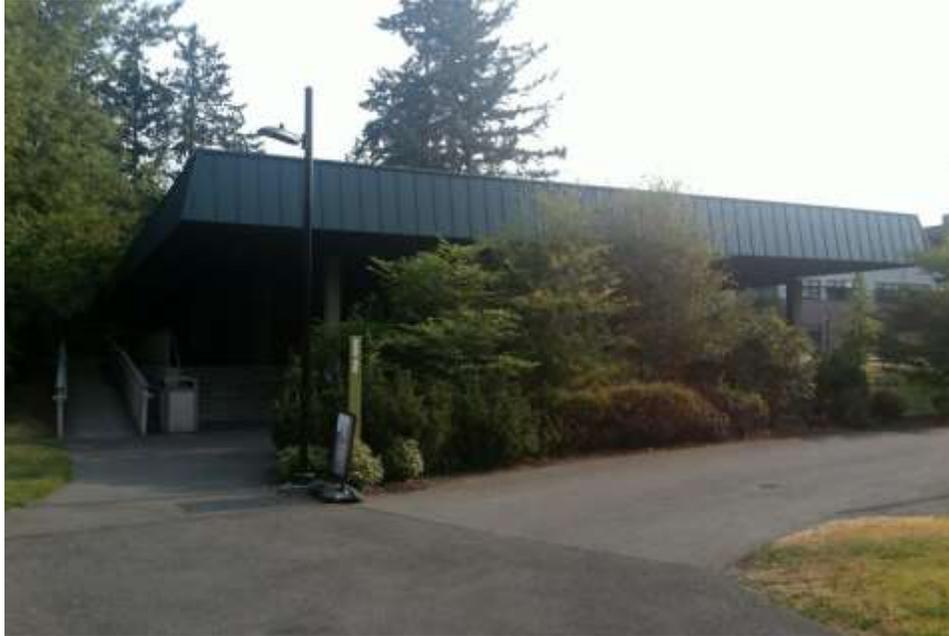
Occupation Education "B" (100-11) STATE UFI: A08202 Main Campus (100A)
 AREA: 8,448 SF BUILT: 1969 REMODELED: No PREDOMINANT USE: Classroom
 CONSTRUCTION TYPE: Medium CRV/SF: \$376 REPLACEMENT VALUE: \$3,176,448

Primary Systems	
COMPONENT: Structure	RATING: 2 x WEIGHT: 8.3 = SCORE: 16.7
Minor cracks evident in a small portion of the structure	
COMMENTS:	
COMPONENT: Exterior Closure	RATING: 2 x WEIGHT: 8.3 = SCORE: 16.7
Weatherproof exterior, but finish appears poorly maintained	
COMMENTS:	
COMPONENT: Roofing	RATING: 3 x WEIGHT: 10.4 = SCORE: 31.3
Some deterioration is evident in membrane and flashings; maintenance or minor repair is needed	
COMMENTS:	EPDM roofing; repairs funded 21-23

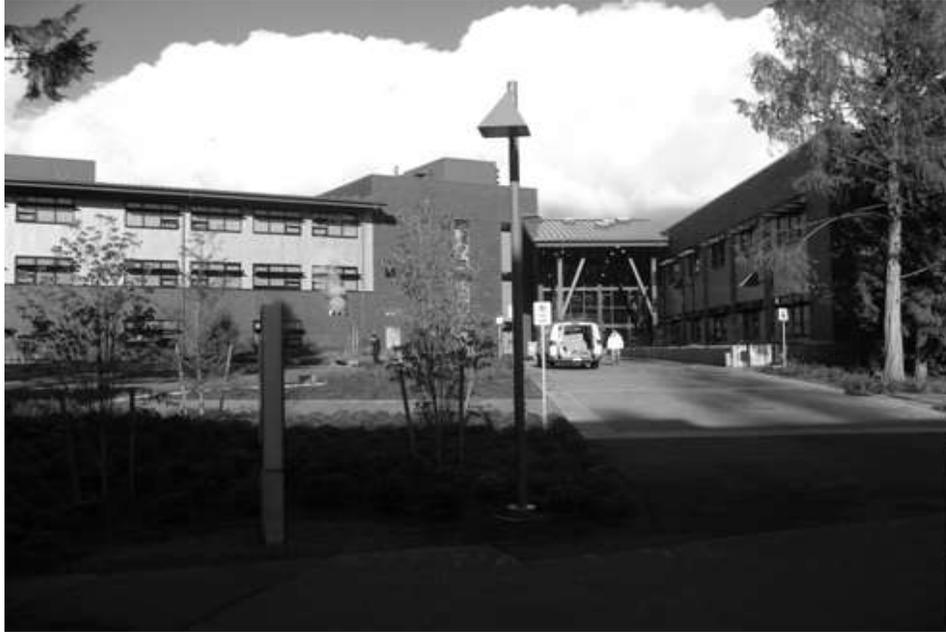
Salish Hall (100-50) STATE UFI: A10108 Main Campus (100A)
 AREA: 87,541 SF BUILT: 2011 REMODELED: No PREDOMINANT USE: General Classroom
 CONSTRUCTION TYPE: Heavy CRV/SF: \$395 REPLACEMENT VALUE: \$34,578,695

Primary Systems	
COMPONENT: Structure	RATING: 1 x WEIGHT: 8 = SCORE: 8
No signs of settlement or cracking, no abrupt vertical changes Columns, bearing walls and roof structure appears sound/free of defects	
COMMENTS: Steel frame	
COMPONENT: Exterior Closure	RATING: 1 x WEIGHT: 8 = SCORE: 8
Weatherproof, tight, well-maintained exterior walls, doors, windows/finishes	
COMMENTS: Brick; metal panels; aluminum window walls; metal soffits	
COMPONENT: Roofing	RATING: 1 x WEIGHT: 10 = SCORE: 10
Flashing and penetrations appear sound and membrane appears water- tight; drainage is positive and there are overflow scuppers	
COMMENTS: TPO single-ply; standing seam metal; skylights

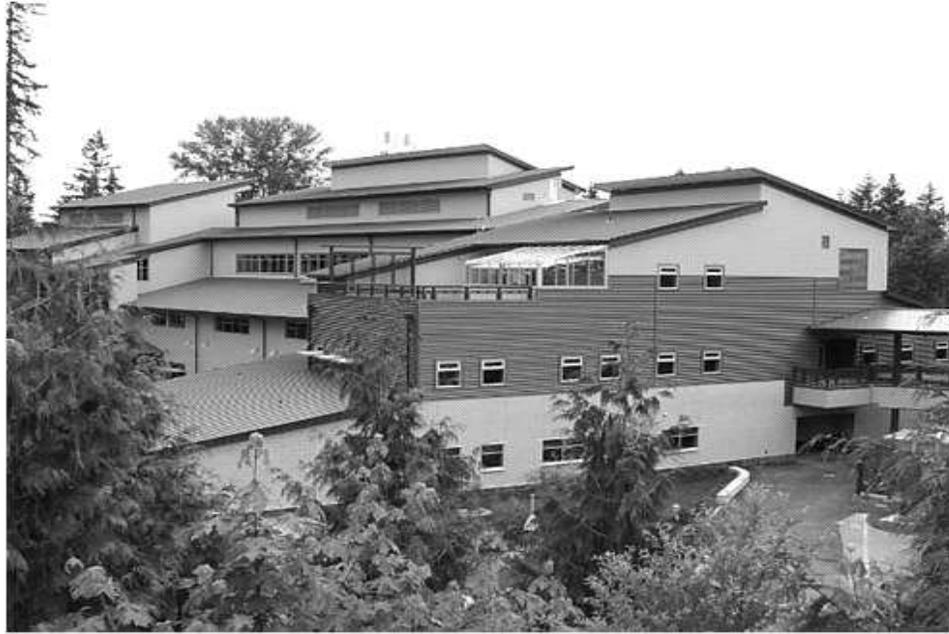
Science Center (100-47) STATE UFI: A05561 Main Campus (100A)
 AREA: 81,258 SF BUILT: 2005 REMODELED: No PREDOMINANT USE: Science Lab.
 CONSTRUCTION TYPE: Heavy CRV/SF: \$489 REPLACEMENT VALUE: \$39,735,162

CONDITION: Superior

Primary Systems	
COMPONENT: Structure	RATING: 1 x WEIGHT: 8.4 = SCORE: 8.4
No signs of settlement or cracking, no abrupt vertical changes Columns, bearing walls and roof structure appears sound/free of defects	
COMMENTS: Structural steel frame; open web steel floor; roof joists	
COMPONENT: Exterior Closure	RATING: 1 x WEIGHT: 8.4 = SCORE: 8.4
Weatherproof, tight, well-maintained exterior walls, doors, windows/finishes	
COMMENTS: CMU; concrete; corrugated and flat metal siding; stucco	
COMPONENT: Roofing	RATING: 1 x WEIGHT: 10.5 = SCORE: 10.5
Flashing and penetrations appear sound and membrane appears water-tight; drainage is positive and there are overflow scuppers	
COMMENTS: Standing seam metal

Secondary Systems			
COMPONENT:	Floor Finishes	RATING: 2 x	WEIGHT: 6.3 = SCORE: 12.6
Some wear is evident on finish; maintenance needed			
COMMENTS:	Polished and unpolished concrete; carpet; linoleum; ceramic tile		
COMPONENT:	Wall Finishes	RATING: 1 x	WEIGHT: 6.3 = SCORE: 6.3
Maintainable surfaces in good condition			
COMMENTS:	Gypsum board; vinyl wall covering; ceramic tile; carved wood panels		
COMPONENT:	Ceiling Finishes	RATING: 1 x	WEIGHT: 6.3 = SCORE: 6.3
Maintainable surfaces in good condition; good alignment and appearance			
COMMENTS:	Gypsum board; suspended wire grid with acoustic backing; lay-in tile; aluminum deck		
COMPONENT:	Doors & Hardware	RATING: 1 x	WEIGHT: 6.3 = SCORE: 6.3
Appropriate hardware, closers, panic devices; in good working order			
COMMENTS:	Interior wood doors/HM frames; exterior aluminum doors/frames

Service Systems			
COMPONENT:	Elevators	RATING: 1 x	WEIGHT: 6.3 = SCORE: 6.3
Appropriate and functional for occupancy and use			
COMMENTS:	3 stop + mechanical penthouse; 1 passenger; 1 freight		
COMPONENT:	Plumbing	RATING: 2 x	WEIGHT: 8.4 = SCORE: 16.8
Fixtures and piping are functional; finishes require maintenance			
COMMENTS:	Copper, steel, and cast iron piping; porcelain fixtures; leaks occur in copper joints		
COMPONENT:	HVAC	RATING: 1 x	WEIGHT: 8.4 = SCORE: 8.4
Equipment in good condition; easily controlled; serves all required spaces; All necessary spaces are adequately ventilated; A/C provided throughout			
COMMENTS:	AHUs with fan-powered VAVs; VAV fume hoods; redundant exhaust fans; chilled/hot water from bldg. 45		
COMPONENT:	Electrical	RATING: 1 x	WEIGHT: 8.4 = SCORE: 8.4
Adequate service and distribution capacity for current/future needs			
COMMENTS:	1600amp 480v		
COMPONENT:	Lights/Power	RATING: 2 x	WEIGHT: 8.4 = SCORE: 16.8

Safety Systems			
COMPONENT:	Life/Safety	RATING: 1 x	WEIGHT: 10.5 = SCORE: 10.5
Appears to meet current codes			
COMMENTS:			
COMPONENT:	Fire Safety	RATING: 1 x	WEIGHT: 10.5 = SCORE: 10.5
Locally monitored detection; alarm and strobes present; sprinklers in high hazard areas			
COMMENTS:			
COMPONENT:	Modifications	RATING: 0 x	WEIGHT: 0 = SCORE: 0
No data			
COMMENTS:	No modifications to date

Quality Standards			
COMPONENT:	Maintenance	RATING: 1 x	WEIGHT: 7.4 = SCORE: 7.4
Facility appears well maintained			
COMMENTS:			
COMPONENT:	Remaining Life	RATING: 1 x	WEIGHT: 6.3 = SCORE: 6.3
Life expectancy is >20 years; minor system deterioration			
COMMENTS:			
COMPONENT:	Appearance	RATING: 1 x	WEIGHT: 6.3 = SCORE: 6.3
Well-constructed building; generally attractive interior and exterior			
COMMENTS:	Attractive, centrally located building highlights campus standard for materials

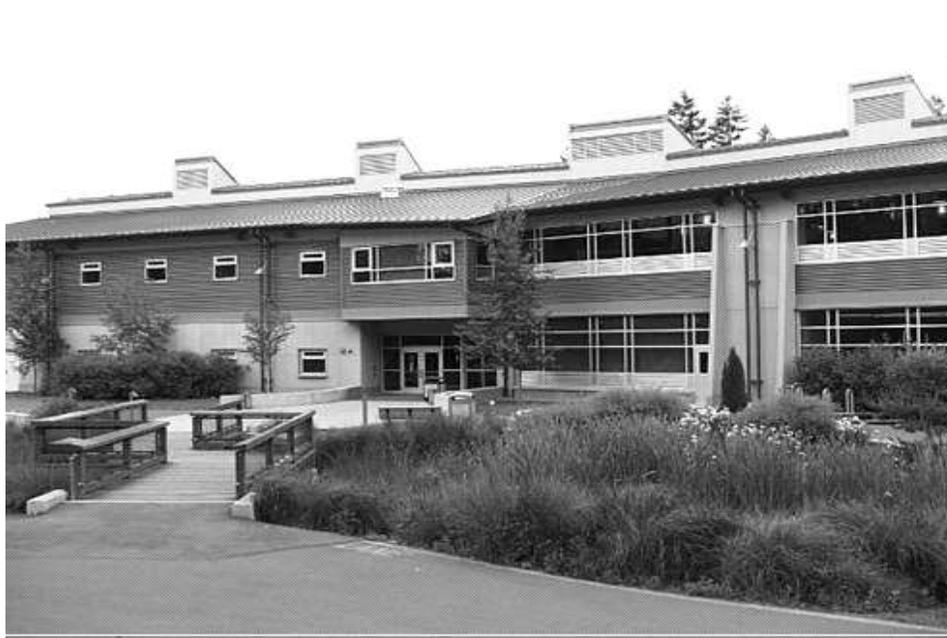
Technology Center (100-45) STATE UFI: A05999 Main Campus (100A)
 AREA: 32,700 SF BUILT: 2004 REMODELED: No PREDOMINANT USE: Computer Lab.
 CONSTRUCTION TYPE: Medium CRV/SF: \$376 REPLACEMENT VALUE: \$12,295,200

CONDITION: Superior

Primary Systems		
COMPONENT:	Structure	RATING: 1 x WEIGHT: 8 = SCORE: 8
No signs of settlement or cracking, no abrupt vertical changes Columns, bearing walls and roof structure appears sound/free of defects		
COMMENTS: Steel frame; glu lams; pre-manufactured trusses		
COMPONENT:	Exterior Closure	RATING: 1 x WEIGHT: 8 = SCORE: 8
Weatherproof, tight, well-maintained exterior walls, doors, windows/finishes		
COMMENTS: Corrugated metal panels; colored concrete panels; stained concrete; metal panels; aluminum window walls		
COMPONENT:	Roofing	RATING: 2 x WEIGHT: 10 = SCORE: 20
Majority of roofing and flashing appear sound, but a small portion of roofing shows deterioration where maintenance or minor repair needed		
COMMENTS: Standing seam metal; glass skylights

COMPONENT:	Floor Finishes	RATING: 2	x	WEIGHT: 6	=	SCORE: 12
	Some wear is evident on finish; maintenance needed					
COMMENTS:	Raised floor grid; carpet tile; stained concrete; ceramic tile; Plexiglas access panels					
COMPONENT:	Wall Finishes	RATING: 1	x	WEIGHT: 6	=	SCORE: 6
	Maintainable surfaces in good condition					
COMMENTS:	Gypsum board; pre-manufactured architectural panels; ceramic tile; folding partition walls					
COMPONENT:	Ceiling Finishes	RATING: 1	x	WEIGHT: 6	=	SCORE: 6
	Maintainable surfaces in good condition; good alignment and appearance					
COMMENTS:	Suspended wood panels; perforated metal panels; gypsum board; lay-in tile					
COMPONENT:	Doors & Hardware	RATING: 1	x	WEIGHT: 6	=	SCORE: 6
	Appropriate hardware, closers, panic devices; in good working order					
COMMENTS:	Interior wood/HM doors/frames; exterior aluminum doors/frames

COMPONENT:	Elevators	RATING: 1	x	WEIGHT: 6	=	SCORE: 6
	Appropriate and functional for occupancy and use					
COMMENTS:	2 stop					
COMPONENT:	Plumbing	RATING: 2	x	WEIGHT: 8	=	SCORE: 16
	Fixtures and piping are functional; finishes require maintenance					
COMMENTS:	Copper, steel; cast iron and PVC piping; porcelain fixtures. Cooling tower repair funded 21-23					
COMPONENT:	HVAC	RATING: 3	x	WEIGHT: 8	=	SCORE: 24
	System generally adequate; some deterioration; needs balancing; some areas have A/C; hazardous areas are ventilated					
COMMENTS:	3 HW boilers and modular chiller (18 modules); cooling tower (2); AHU with under floor fan powered VAVs; floors used as plenum; inefficient					
COMPONENT:	Electrical	RATING: 1	x	WEIGHT: 8	=	SCORE: 8
	Adequate service and distribution capacity for current/future needs					
COMMENTS:	2000amp 208v; 105kW generator					
COMPONENT:	Lights/Power	RATING: 1	x	WEIGHT: 8	=	SCORE: 8

Safety Systems		
COMPONENT:	Life/Safety	RATING: 1 x WEIGHT: 10 = SCORE: 10
	Appears to meet current codes	
COMMENTS:		
COMPONENT:	Fire Safety	RATING: 1 x WEIGHT: 10 = SCORE: 10
	Locally monitored detection; alarm and strobes present; sprinklers in high hazard areas	
COMMENTS:		
COMPONENT:	Modifications	RATING: 1 x WEIGHT: 7 = SCORE: 7
	Modifications appear to be in compliance with codes and sound construction practices; HVAC/electrical service properly provided	
COMMENTS: None evident

Quality Standards		
COMPONENT:	Maintenance	RATING: 1 x WEIGHT: 7 = SCORE: 7
	Facility appears well maintained	
COMMENTS:		
COMPONENT:	Remaining Life	RATING: 1 x WEIGHT: 6 = SCORE: 6
	Life expectancy is >20 years; minor system deterioration	
COMMENTS:		
COMPONENT:	Appearance	RATING: 1 x WEIGHT: 6 = SCORE: 6
	Well-constructed building; generally attractive interior and exterior	
COMMENTS: Attractive, centrally located building highlights campus standard for materials

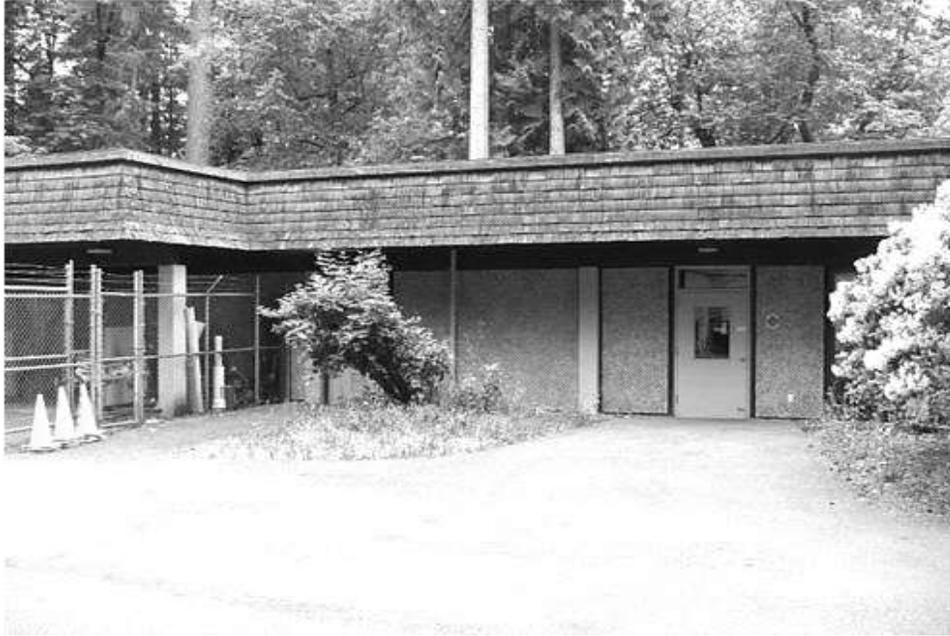
Water Technology (100-26) STATE UFI: A00569 Main Campus (100A)
 AREA: 4,480 SF BUILT: 1982 REMODELED: No PREDOMINANT USE: Science Lab.
 CONSTRUCTION TYPE: Medium CRV/SF: \$489 REPLACEMENT VALUE: \$2,190,720

CONDITION: Needs Improvement/Renovation

Primary Systems	
COMPONENT: Structure	RATING: 1 x WEIGHT: 8.8 = SCORE: 8.8
No signs of settlement or cracking, no abrupt vertical changes Columns, bearing walls and roof structure appears sound/free of defects	
COMMENTS: Concrete; glu-lam beams; wood roof trusses; wood frame	
COMPONENT: Exterior Closure	RATING: 2 x WEIGHT: 8.8 = SCORE: 17.6
Weatherproof exterior, but finish appears poorly maintained	
COMMENTS: Precast concrete panels; wood soffits	
COMPONENT: Roofing	RATING: 1 x WEIGHT: 11 = SCORE: 11
Flashing and penetrations appear sound and membrane appears water-tight; drainage is positive and there are overflow scuppers	
COMMENTS: Single-ply 2018

COMPONENT:	Floor Finishes	RATING: 2	x	WEIGHT: 6.6	=	SCORE: 13.2
Some wear is evident on finish; maintenance needed						
COMMENTS:	Carpet; vinyl tile; concrete; ceramic tile; wood strips					
COMPONENT:	Wall Finishes	RATING: 1	x	WEIGHT: 6.6	=	SCORE: 6.6
Maintainable surfaces in good condition						
COMMENTS:	Gypsum board and ceramic tile					
COMPONENT:	Ceiling Finishes	RATING: 3	x	WEIGHT: 6.6	=	SCORE: 19.8
Some wear and tear; Minor damage, staining or deterioration						
COMMENTS:	Gypsum board; direct adhered tile; lay-in tile-holes/stains					
COMPONENT:	Doors & Hardware	RATING: 3	x	WEIGHT: 6.6	=	SCORE: 19.8
Functional, but dated; some maintenance required						
COMMENTS:	Interior wood doors/aluminum frames-surface wear; exterior HM doors/frames; OH wood doors

COMPONENT:	Elevators	RATING: 0	x	WEIGHT: 0	=	SCORE: 0
No data						
COMMENTS:						
COMPONENT:	Plumbing	RATING: 3	x	WEIGHT: 8.8	=	SCORE: 26.3
Fixtures are functional but dated; some leaks; maintenance required						
COMMENTS:	Copper, cast iron, and galvanized piping; porcelain fixtures					
COMPONENT:	HVAC	RATING: 2	x	WEIGHT: 8.8	=	SCORE: 17.6
Equipment in fair condition; minor deterioration; controls require troubleshooting; most areas have A/C; hazardous areas are ventilated						
COMMENTS:	HW boiler and 2 split system units 2012					
COMPONENT:	Electrical	RATING: 1	x	WEIGHT: 8.8	=	SCORE: 8.8
Adequate service and distribution capacity for current/future needs						
COMMENTS:	200amp 208/120v					
COMPONENT:	Lights/Power	RATING: 2	x	WEIGHT: 8.8	=	SCORE: 17.6
Contemporary lighting with good work area illumination; adequate number of outlets; some finishes appear aged						
COMMENTS:	Ceiling mount and lay-in fluorescent lighting

COMPONENT:	Life/Safety	RATING: 3	x	WEIGHT: 11	=	SCORE: 32.9
Generally meets codes for vintage of construction						
COMMENTS:						
COMPONENT:	Fire Safety	RATING: 2	x	WEIGHT: 11	=	SCORE: 22
Locally monitored detection; alarm present, but missing visual component or sprinklers						
COMMENTS:						
COMPONENT:	Modifications	RATING: 0	x	WEIGHT: 0	=	SCORE: 0
No data						
COMMENTS: None evident

COMPONENT:	Maintenance	RATING: 2	x	WEIGHT: 7.7	=	SCORE: 15.4
Routine maintenance is required; impact is minor						
COMMENTS:						
COMPONENT:	Remaining Life	RATING: 3	x	WEIGHT: 6.6	=	SCORE: 19.8
Life expectancy is roughly 10-15 years; moderate system deterioration						
COMMENTS:						
COMPONENT:	Appearance	RATING: 3	x	WEIGHT: 6.6	=	SCORE: 19.8
Average construction; average interior and exterior appearance						
COMMENTS: Very dated, dark, moderate scale building

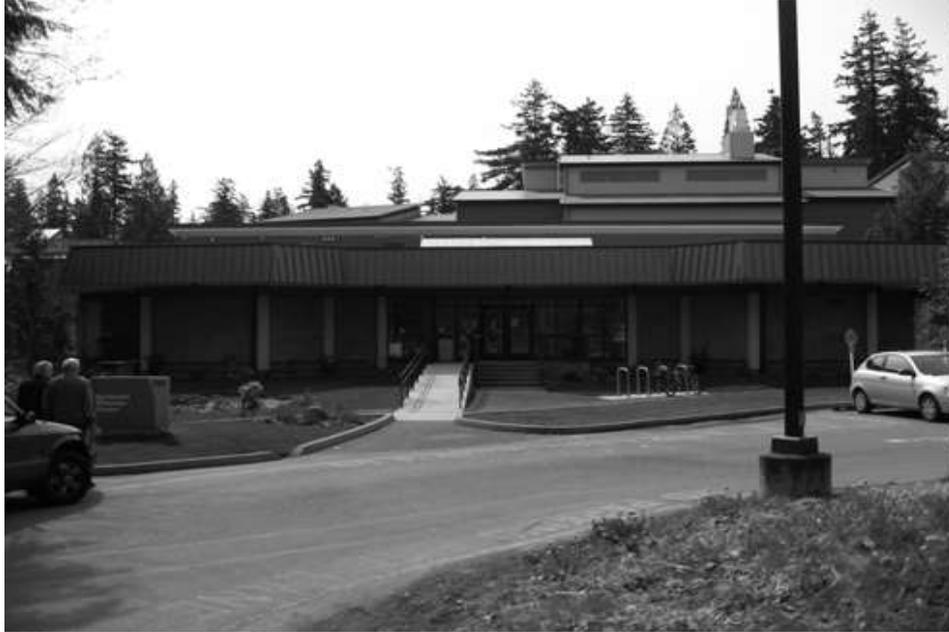
Zgolinski Welcome Center (100-31) STATE UFI: A01459 Main Campus (100A)
 AREA: 10,772 SF BUILT: 1990 REMODELED: 2008 PREDOMINANT USE: Administration
 CONSTRUCTION TYPE: Medium CRV/SF: \$336 REPLACEMENT VALUE: \$3,619,392

CONDITION: Needs Improvement/Additional Maintenance

Primary Systems	
COMPONENT: Structure	RATING: 1 x WEIGHT: 8.3 = SCORE: 8.3
No signs of settlement or cracking, no abrupt vertical changes Columns, bearing walls and roof structure appears sound/free of defects	
COMMENTS: Concrete; glu-lam beams; wood frame; concrete columns	
COMPONENT: Exterior Closure	RATING: 1 x WEIGHT: 8.3 = SCORE: 8.3
Weatherproof, tight, well-maintained exterior walls, doors, windows/finishes	
COMMENTS: Precast concrete panels; stucco; metal corrugated panels; aluminum storefronts	
COMPONENT: Roofing	RATING: 2 x WEIGHT: 10.4 = SCORE: 20.9
Majority of roofing and flashing appear sound, but a small portion of roofing shows deterioration where maintenance or minor repair needed	
COMMENTS: Hypalon single-ply membrane-1990; metal 2008; skylights;

COMPONENT:	Floor Finishes	RATING: 1	x	WEIGHT: 6.3	=	SCORE: 6.3
	Nice appearance, smooth transitions, level subfloors, no cracks/separating					
COMMENTS:	Ceramic tile; carpet					
COMPONENT:	Wall Finishes	RATING: 1	x	WEIGHT: 6.3	=	SCORE: 6.3
	Maintainable surfaces in good condition					
COMMENTS:	Gypsum board; ceramic tile; interior glass window walls					
COMPONENT:	Ceiling Finishes	RATING: 1	x	WEIGHT: 6.3	=	SCORE: 6.3
	Maintainable surfaces in good condition; good alignment and appearance					
COMMENTS:	Lay-in tile; gypsum board					
COMPONENT:	Doors & Hardware	RATING: 1	x	WEIGHT: 6.3	=	SCORE: 6.3
	Appropriate hardware, closers, panic devices; in good working order					
COMMENTS:	Interior wood doors/HM frames; exterior aluminum doors/frames

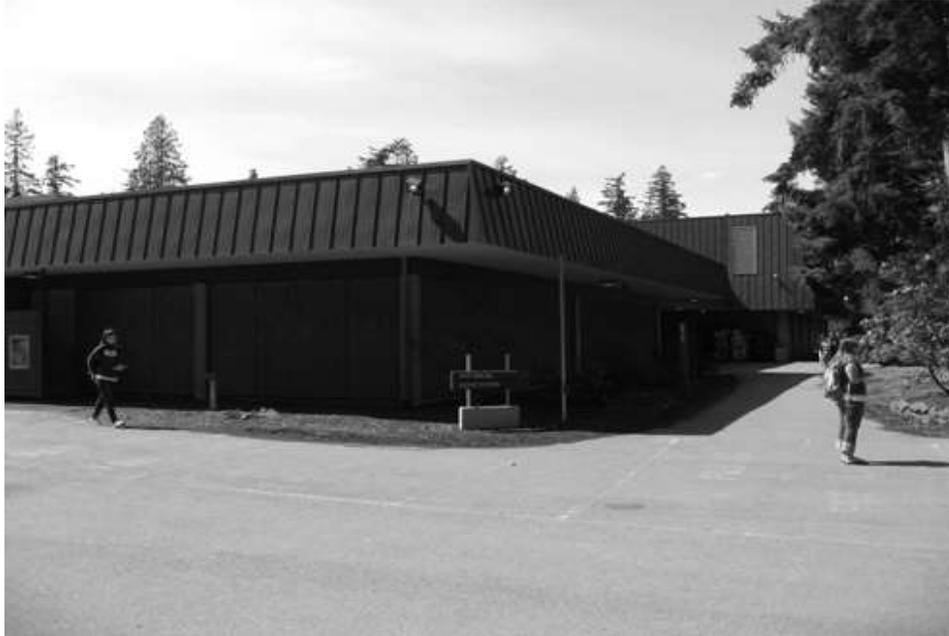
Physical Education (100-5) STATE UFI: A06045 Main Campus (100A)
 AREA: 28,473 SF BUILT: 1967 REMODELED: 2009 PREDOMINANT USE: Gymnasium
 CONSTRUCTION TYPE: Heavy CRV/SF: \$349 REPLACEMENT VALUE: \$9,937,077

CONDITION: Superior

Primary Systems	
COMPONENT: Structure	RATING: 1 x WEIGHT: 8.7 = SCORE: 8.7
No signs of settlement or cracking, no abrupt vertical changes Columns, bearing walls and roof structure appears sound/free of defects	
COMMENTS: Concrete frame; CMU; glu lam beams	
COMPONENT: Exterior Closure	RATING: 2 x WEIGHT: 8.7 = SCORE: 17.4
Weatherproof exterior, but finish appears poorly maintained	
COMMENTS: Exposed concrete aggregate panels; wood soffits; standing seam metal mansards	
COMPONENT: Roofing	RATING: 2 x WEIGHT: 10.9 = SCORE: 21.8
Majority of roofing and flashing appear sound, but a small portion of roofing shows deterioration where maintenance or minor repair needed	
COMMENTS: Upper roof PVC single-ply-2004; lower roof PVC single-ply-2008; skylights

Secondary Systems			
COMPONENT:	Floor Finishes	RATING: 2 x	WEIGHT: 6.5 = SCORE: 13.1
Some wear is evident on finish; maintenance needed			
COMMENTS:	Carpet; rubber; strip hardwood and concrete; ceramic tile		
COMPONENT:	Wall Finishes	RATING: 2 x	WEIGHT: 6.5 = SCORE: 13.1
Maintainable surfaces, minor maintenance is required in some areas			
COMMENTS:	Gypsum board; CMU; tectum panels; ceramic tile; vent wood		
COMPONENT:	Ceiling Finishes	RATING: 1 x	WEIGHT: 6.5 = SCORE: 6.5
Maintainable surfaces in good condition; good alignment and appearance			
COMMENTS:	Gypsum board; direct adhered tile; exposed structure; lay-in tile		
COMPONENT:	Doors & Hardware	RATING: 2 x	WEIGHT: 6.5 = SCORE: 13.1
Fairly modern door surfaces and hardware with minor deterioration; good working order			
COMMENTS:	Interior HM and laminate doors w HM frames; exterior wood and HM doors/frames

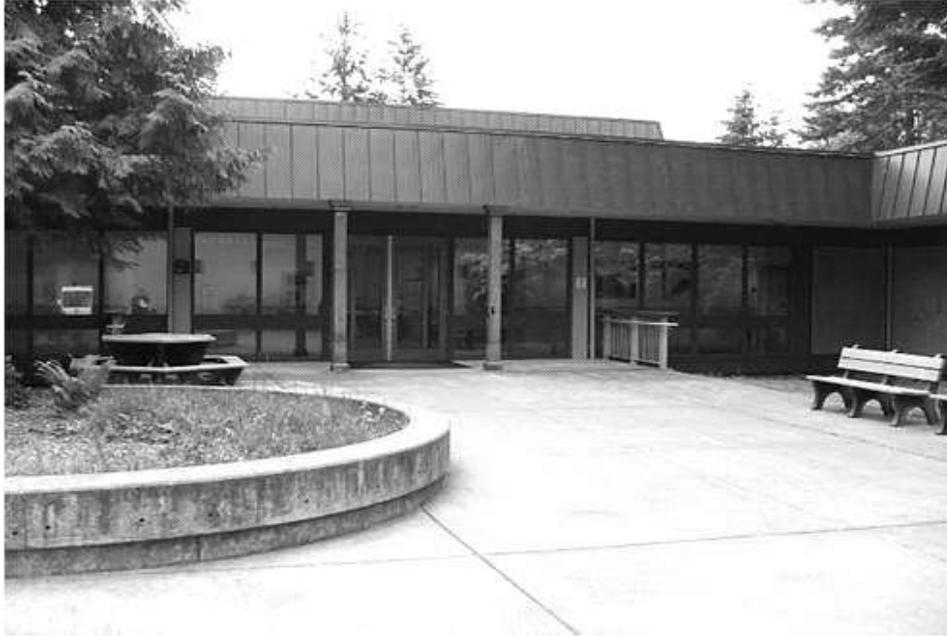
Rutkowski Learning Center (100-1) STATE UFI: A07189 Main Campus (100A)
 AREA: 35,680 SF BUILT: 1965 REMODELED: 1997 PREDOMINANT USE: General Classroom
 CONSTRUCTION TYPE: Medium CRV/SF: \$376 REPLACEMENT VALUE: \$13,415,680

CONDITION: Adequate

Primary Systems	
COMPONENT: Structure	RATING: 1 x WEIGHT: 8.3 = SCORE: 8.3
No signs of settlement or cracking, no abrupt vertical changes Columns, bearing walls and roof structure appears sound/free of defects	
COMMENTS: Concrete frame; glu-lam beams	
COMPONENT: Exterior Closure	RATING: 1 x WEIGHT: 8.3 = SCORE: 8.3
Weatherproof, tight, well-maintained exterior walls, doors, windows/finishes	
COMMENTS: Precast concrete panels; stucco soffits	
COMPONENT: Roofing	RATING: 2 x WEIGHT: 10.4 = SCORE: 20.9
Majority of roofing and flashing appear sound, but a small portion of roofing shows deterioration where maintenance or minor repair needed	
COMMENTS: Hypalon roof; metal mansards

Secondary Systems			
COMPONENT:	Floor Finishes	RATING: 1 x WEIGHT: 6.3 =	SCORE: 6.3
	Nice appearance, smooth transitions, level subfloors, no cracks/separating		
COMMENTS:	Carpet-surface wear; carpet tile; ceramic tile		
COMPONENT:	Wall Finishes	RATING: 1 x WEIGHT: 6.3 =	SCORE: 6.3
	Maintainable surfaces in good condition		
COMMENTS:	Gypsum board; wood chair rail; rubber base; ceramic tile		
COMPONENT:	Ceiling Finishes	RATING: 1 x WEIGHT: 6.3 =	SCORE: 6.3
	Maintainable surfaces in good condition; good alignment and appearance		
COMMENTS:	Lay-in tile		
COMPONENT:	Doors & Hardware	RATING: 1 x WEIGHT: 6.3 =	SCORE: 6.3
	Appropriate hardware, closers, panic devices; in good working order		
COMMENTS:	Interior wood/HM doors and HM frames; exterior wood doors/frames
